NATIONAL PROGRAM FOR INSPECTION OF NON-FEDERAL DAMS
GLEN LAKE DAM (CT 003..(U) CORPS OF ENGINEERS WALTHAM
MA NEW ENGLAND DIV AUG 79

4. TITLE (and Subtitle) Glen Lake Dam NATIONAL PROGRAM FOR INSPECTION OF NON-FEDERAL DAMS		5. TYPE OF REPORT & PERIOD COVERED INSPECTION REPORT
7. AUTHOR(s) U.S. ARMY CORPS OF ENGINEERS NEW ENGLAND DIVISION		6. PERFORMING ORG. REPORT NUMBER

The 380⁺ foot long dam is a concrete gravity section rising approximately 62 feet above the bed of the Sargent River. The dam is founded on bedrock with the deepest foundation extending to 75 feet below the top of the dam. The spillway at the right end of the dam, is a concrete ogee section 40 feet in width, with 9 feet of freeboard from the crest of the spillway to the top of the dam.

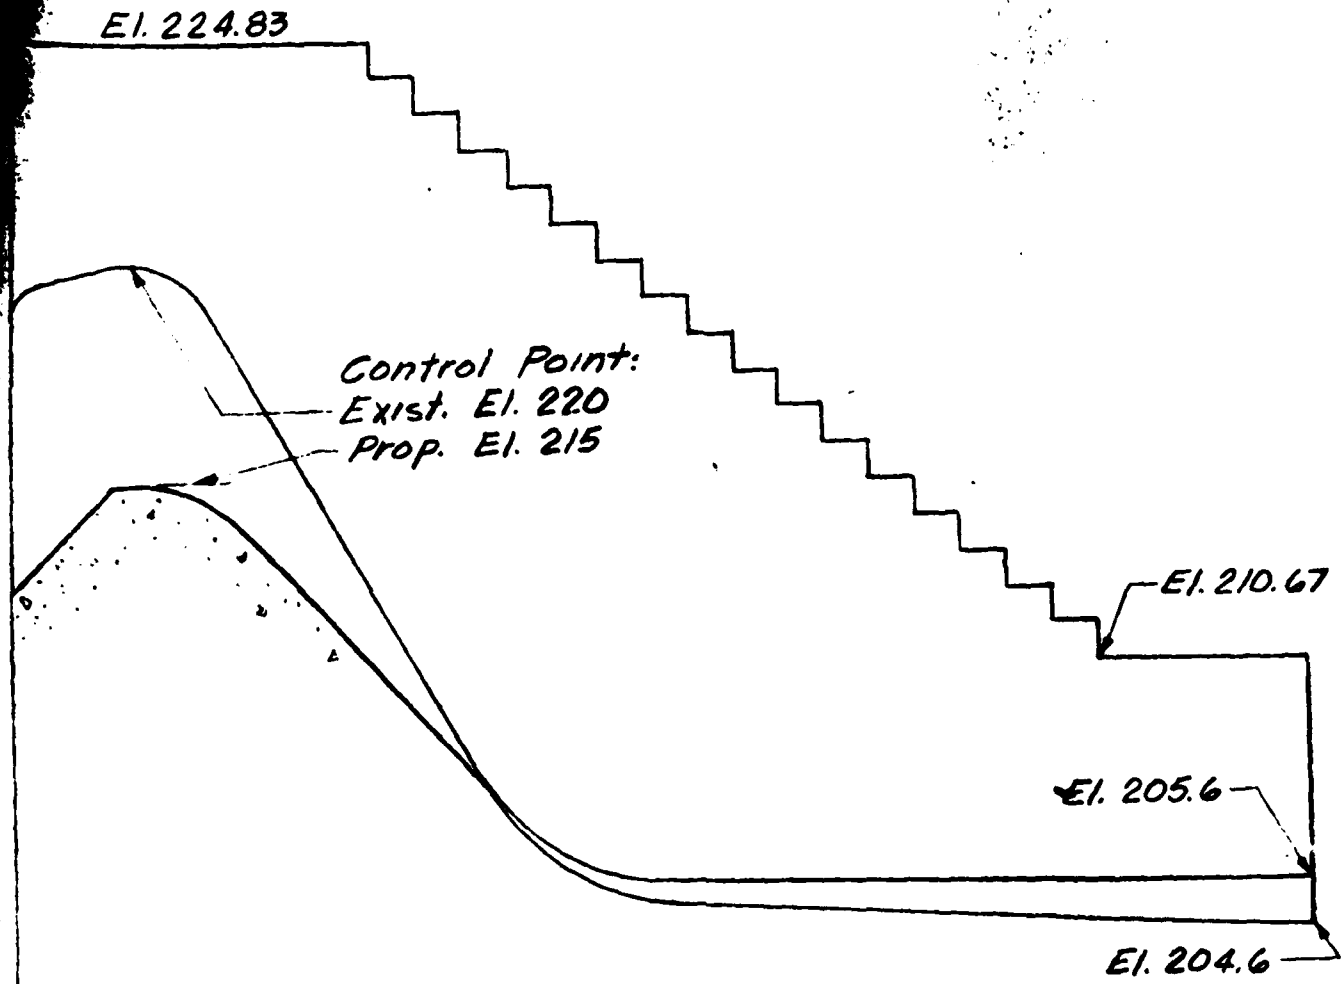
Fig. 3

SECTION THROUGH SPILLWAY
SCALE: 1/4" = 1'-0"

PROPOSED METHOD OF
LOWERING GLEN SPILLWAY

Although the urgency of providing more outflow capacity for Glen is not as great as for Dawson, it is advisable to modify the Glen spillway at an early date. The least expensive method of doing so appears to be by lowering the spillway crest as shown in Figure 3 to permit passing future extreme floods without overtopping the non-overflow section of the dam. For the 1,000-year storm used in our study, the spillway should be lowered at least 2 feet. For the Westfield storm it should be lowered 5 feet. In view of the uncertainty of all methods of estimating future flood conditions and the minor effect on system operation if this plan is followed, we recommend lowering the Glen spillway by 5 feet. The cost of cutting down and reshaping the spillway crest is estimated to be of the magnitude of \$5,000. The work does not require extensive preparation and can be started at any time.
